# **FABRICATION AND VERIFICATION TESTING OF ETM 30 CM DIAMETER ION THRUSTERS**

**FINAL REPORT**

**ION PHYSICS DEPARTMENT STAFF  
HUGHES RESEARCH LABORATORIES  
A DIVISION OF HUGHES AIRCRAFT COMPANY  
3011 MALIBU CANYON ROAD  
MALIBU, CALIFORNIA 90265**

**CONTRACT NAS 3-17803  
JAMES S. SOVEY, PROGRAM MANAGER**

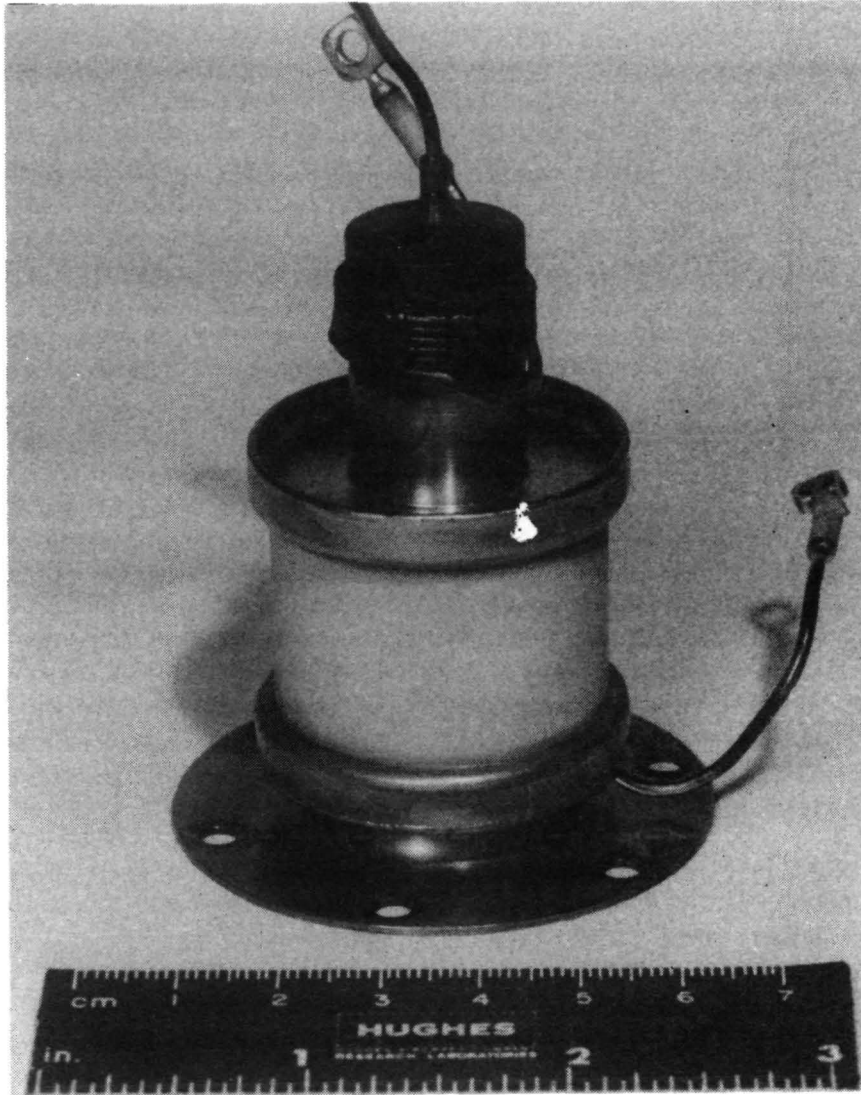
Figure A-128. MIV after endurance test.
